GEOTECHNICAL COMPLETION REPORT RESIDENTIAL SUBDIVISION - STAGE ONE 129 BEACHLANDS ROAD BEACHLANDS

> Reference: 8917-5 9 August 2016

KGA Geotechnical Limited

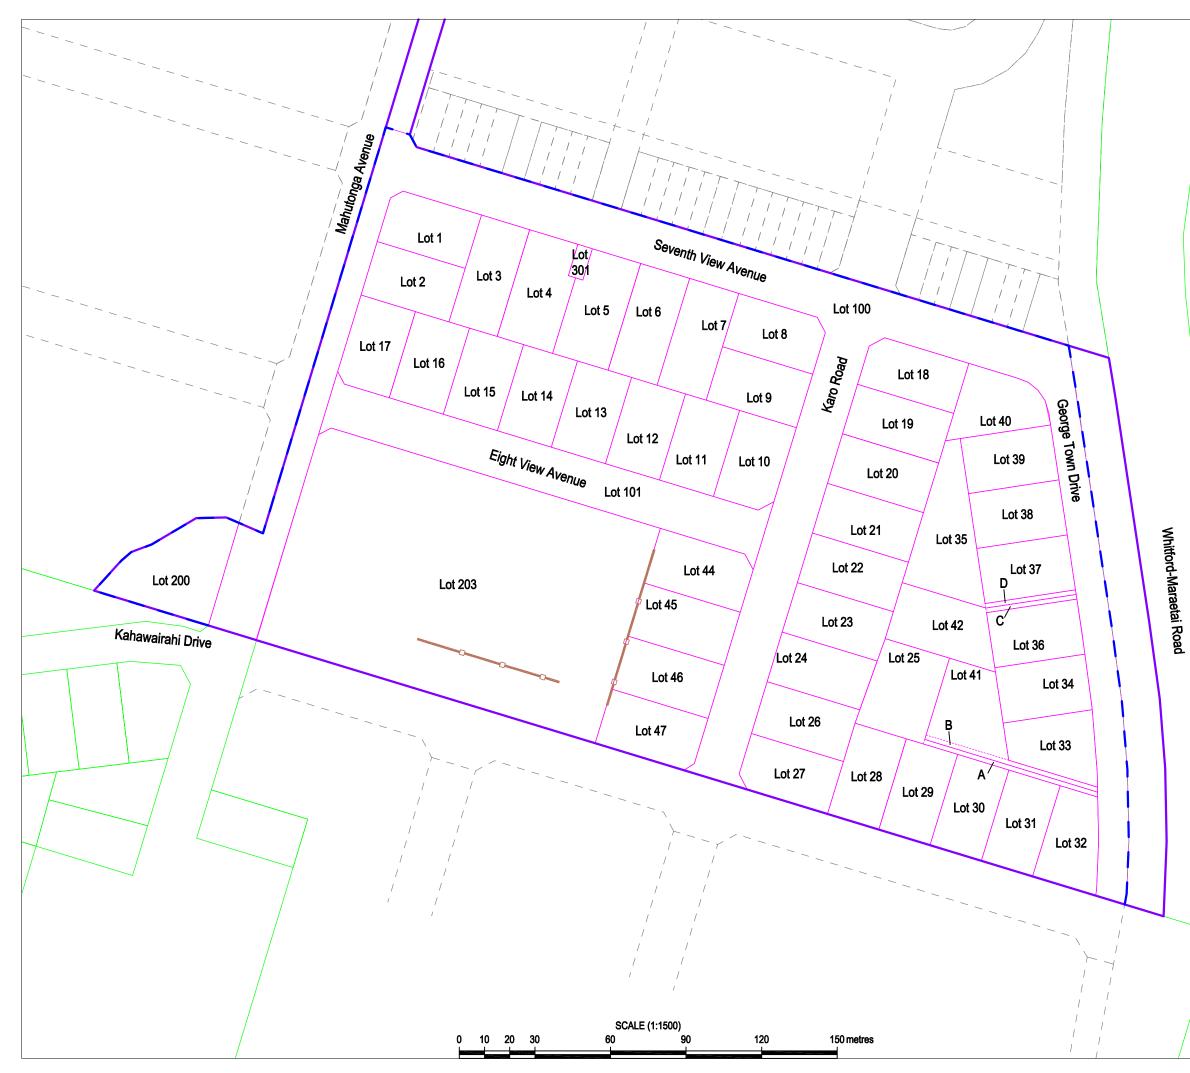
Key:	
		ect site overall boundary
North (approx)	^ ~ ~ ^ ~ Stagi	ng boundary
	New	Lots
	Othe	r properties existing legal daries
		n proposed future developments de of subject site boundary
	Retai	ning walls
	Notes:

1. Subdivision layout, including from drawings prepared by (Limited	retaining wall locations, adapted Crang Civil Consulting Engineers
	2. Locations of all buried servic construction	es to be verified prior to

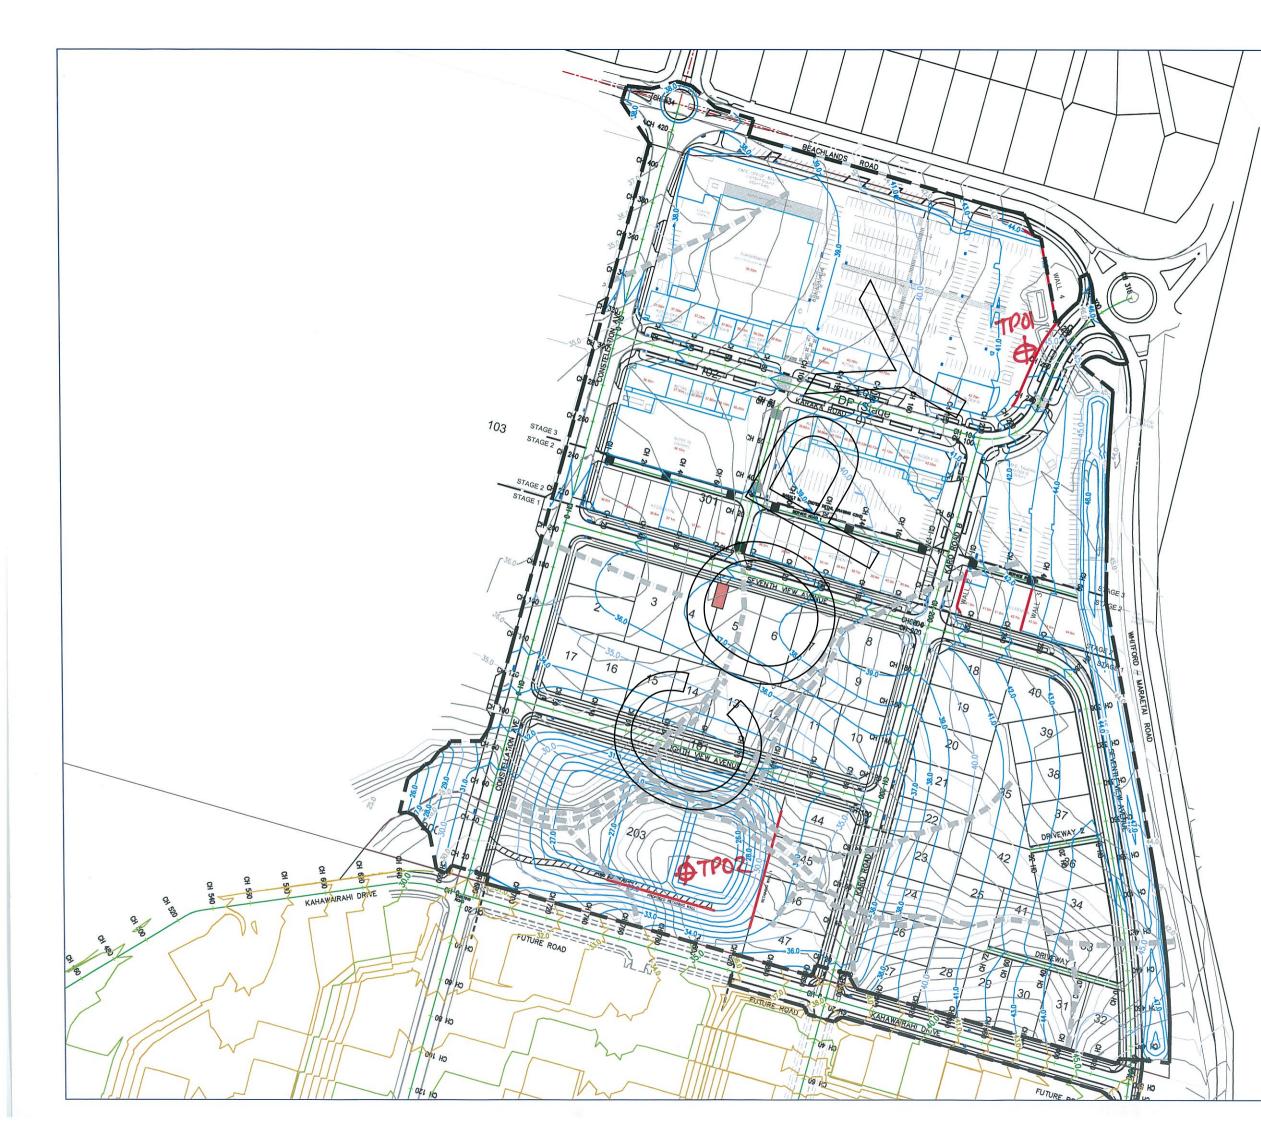
EAR	THWORKS	PLA	N
DATE	FEB 2015		SCALE
DRAWN	DW	A1	1:1000
DESIGNED		A3	1:2000
DRAWING No C2	00 SHEET of .	1 REVI	SION

- Email correspondence dated 5 October 2015, from S&R to CCCE, subject "FW: Pine Roots".
- Email correspondence dated 6 October 2015, from S&R to CCCE, subject "15542-Beachlands Compaction Data.
- Laboratory test results prepared by Babbage Geotechnical Laboratory for S&R, dated 2 October 2015.
- Moisture Content Report, prepared by S&R, dated 24 September 2015.
- Hand annotated CCCE plan titled 'Earthworks', drawing No. C200, dated 14 August 2015
